MILLEN LAKE DAM

NH 00236

PHASE I INSPECTION REPORT NATIONAL DAM INSPECTION PROGRAM

MARCH 1980

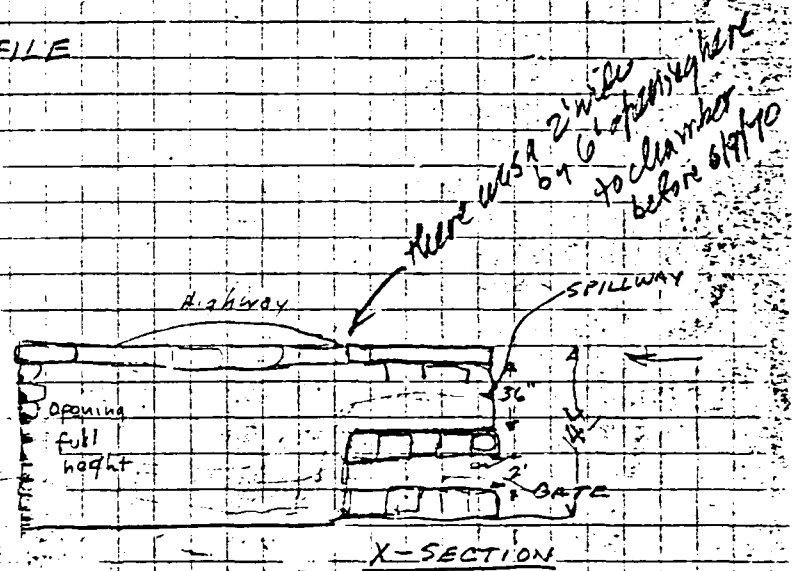
X-SECTION

TYPE - STONE
 CONDITION - GOOD (LEAKS AT BASE)
 Gate raised by chain. Kept locked.
